AVIATION INVESTIGATION REPORT

A04H0002

COLLISION WITH WATER

de HAVILLAND DHC-2 MK 1 C-GJST

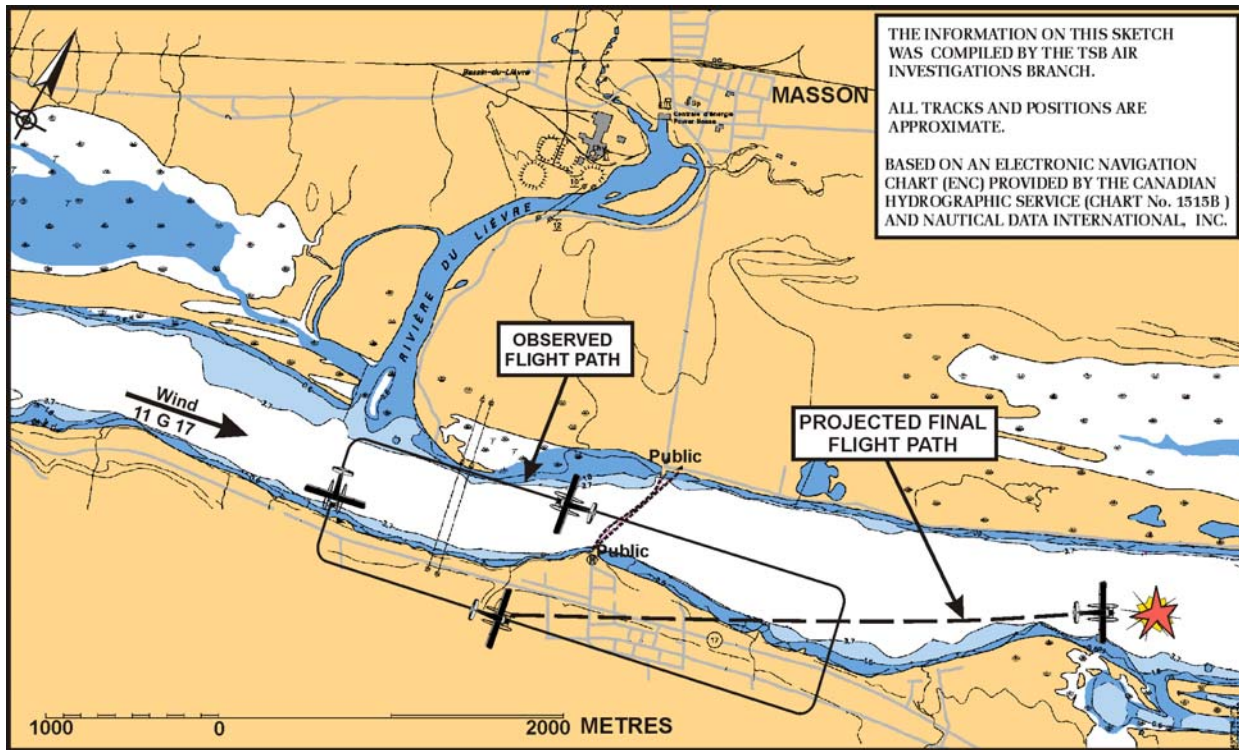
Figure 1. Aircraft flight path

On the morning of the accident, the pilot appeared to be well rested. He went to the shop where he worked to assign tasks to his employees, then he planned some family activities for late that day. In the late morning, as he had been doing regularly for several years, he went to his chiropractor's for a treatment session before coming back for his flight, which he was looking forward to. The pilot did a pre-flight inspection before starting the engine and taking off in a westerly direction. He made some upwind touch-and-go landings in a westerly direction, as he was accustomed to doing. The aircraft was then observed about 50 feet above the river, two miles east of the place where the first landings were made (see Figure 1), with a tail wind and a nose-down attitude of over 20 degrees. A few feet above the surface, the aircraft banked slightly right and its nose-down attitude increased slightly. The impact with the surface of the river destroyed the aircraft, which sank within a few minutes.

- was two miles east of its original position;
- was in a section of the river that provided no protection from the elements;
- was approaching the surface of the water with a tail wind gusting to 17 knots;
- had the flaps retracted; and
- was in an excessive nose-down attitude of over 20 degrees.
